Prüfbericht - Nr.: <i>Test Report No.:</i>	IND/BLR/CH/2019/5267 ULR No.: TC568819500002673F	Seite 1 von 3 <i>Page 1 of 3</i>	
Auftraggeber: <i>Client:</i>	Proton Super abrasives, Old No.:3/New No.:8, Doraisamy Street, Visalakshi Nagar, Ekkatthuthangal, Chennai - 600 032. Tamilnadu		
Gegenstand der Prüfung: <i>Test item:</i>	Material: Car Painted Part Proklear Raw Xtreme CX Waterless Rinse less Car Wash Concentrate		
Bezeichnung: <i>Identification:</i>	-	Serien-Nr.: <i>Serial No./Document Submitted:</i>	Test Request Format
Wareneingangs-Nr.: <i>Receipt No.:</i>	04072019	Eingangsdatum: <i>Date of receipt:</i>	04.07.2019
Order No.:	166153478	Testing Period:	06.07.2019 to 09.07.2019
Prüfort: <i>Testing location:</i>	TÜV Rheinland India Pvt Ltd, Plot No.27/B, 2 nd Cross Road, Electronic City Phase I, Hosur Road, Bangalore - 560 100, Karnataka, India.		
Prüfgrundlage: <i>Test Method:</i>	Customer Requirement: Salt Fog Test as per ASTM B117-18

TEST RESULTS

Discipline: Chemical
Product group: Corrosion Test

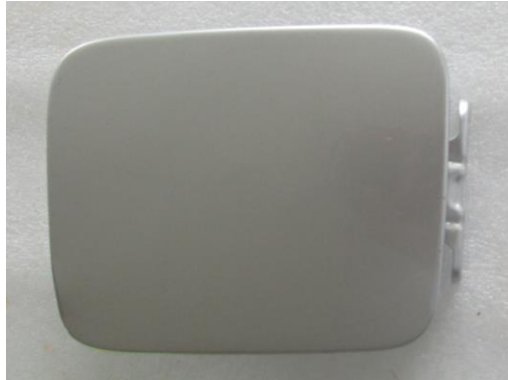
Before Testing

1	Product Description and Condition :			
	Description	: Material: Car Painted Part Proklear Raw Xtreme CX Waterless Rinse less Car Wash Concentrate		
	Condition (As Received)	: Free from Visible defects and corrosion marks when it was received.		
2	Equipment Used : Corrosion Tester			
Sl. No.	Equipment ID	Description	Make	Cal Due Date
1	40-2015-0360	Corrosion Tester	CM Enviro	22.03.2020
2	40-2014-0312	PH Meter	EUTECH Instruments	Daily calibration
3	40-2011-0238	Conductivity Meter	Hanna Instruments	Daily calibration
3	Test Conditions :			
Sl. No.	Parameter	Specification	Observations	
1	Test solution	5% NaCl Solution	5% NaCl Solution	
2	Type of Water used	Type IV water as per ASTM D1193-06(2018) standard	Type IV water as per ASTM D1193-06(2018) standard	
3	Method of preparation of the test specimen	As per Clause 6 of ASTM B117-18	Cleaned with Type IV water as per ASTM D1193-06(2018) standard	
4	Number of specimen tested	01	01

0.5 ml of the Proklear Raw Xtreme CX Waterless Rinse less Car Wash Concentrate to be diluted with DM Water to 100 ml. To be applied to sample painted test piece supplied by wiping and buffing after 1 minute.

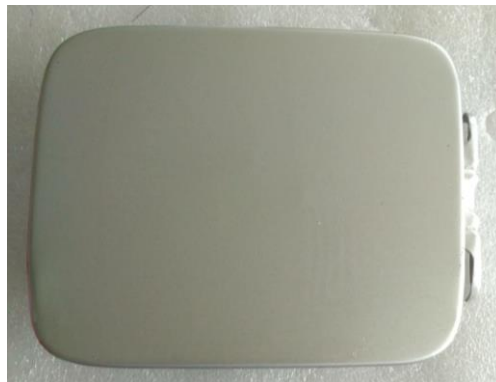
After Testing

- No Sign of corrosion observed on the surface of the sample.
- No Blisters, Pits are observed on the surface of the sample.
